Manhole Inspection Summary

Manhole # S49GG_011MH

Inspection ☐ Is Incomplete Rating: **3) Fair**

Insp Date: **8/11/08 9:59 AM**

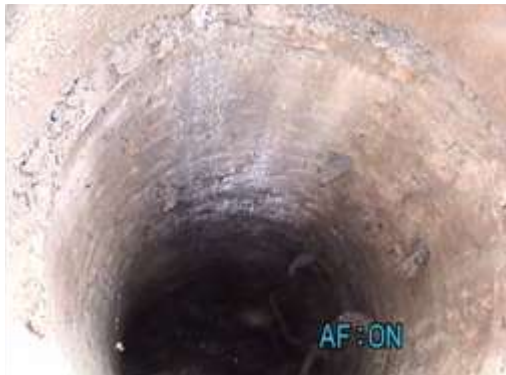
Defect 2

Infiltration

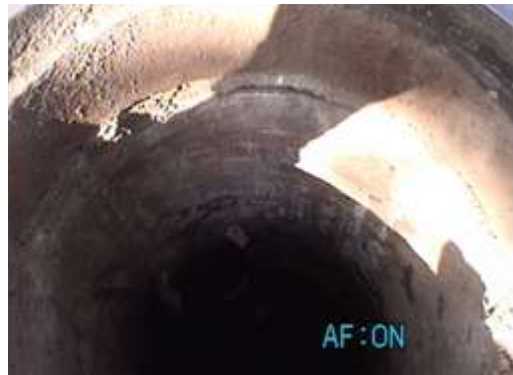
Defect 1

frame leaks

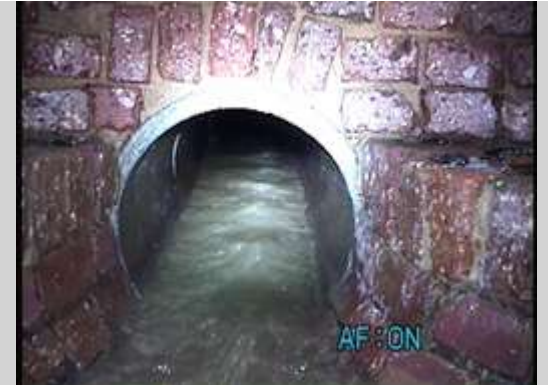
12 O'Clock Outflow

15 in. Circular Gravity Sewer
Pipe Out @ 12 O'Clock

Pipe Height: **15.6** (in.) Rod and Bar (Angled)
Pipe Material: **Clay** ☐ Pipe Lined
Invert Depth: **15.60** (ft.) Flow Characteristics: **Fast**
Deposits: ☒ None ☐ Mud ☐ Sludge ☐ Debris ☐ Grease
Silt Depth: (in.) Deposits Extent:
Infiltration: **None** Pipe Seal Cond: **Sound**

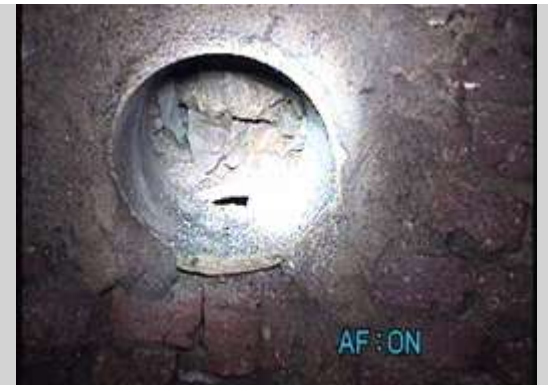
3 O'Clock Inflow

8 in. Circular Gravity Sewer
Pipe In @ 3 O'Clock

Pipe Height: **8.4** (in.) Rod and Bar (Angled)
Pipe Material: **Clay** ☐ Pipe Lined
Invert Depth: **8.70** (ft.) Flow Characteristics: **Fast**
Deposits: ☒ None ☐ Mud ☐ Sludge ☐ Debris ☐ Grease
Silt Depth: (in.) Deposits Extent:
Infiltration: **None** Pipe Seal Cond: **Sound**

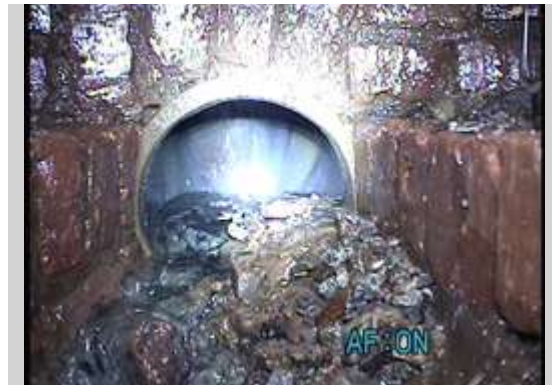
Drop In @ 3 O'Clock

Drop: **Inside** Rod and Bar
Angled: **Yes** Reading: **14.20** (ft.)
Inv Depth: **15.20** (ft.)
Drop Condition: **Open**

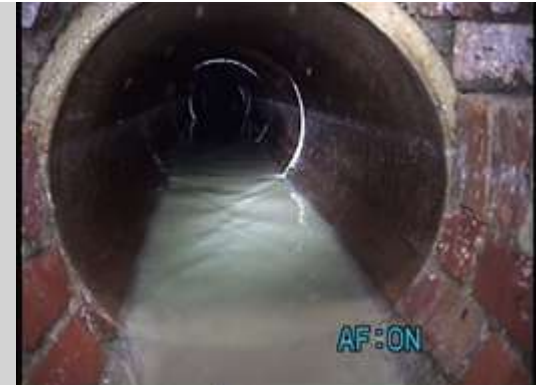
6 O'Clock Inflow

Pipe In @ 6 O'Clock

Infiltration: **None** Pipe Seal Cond: **Sound**

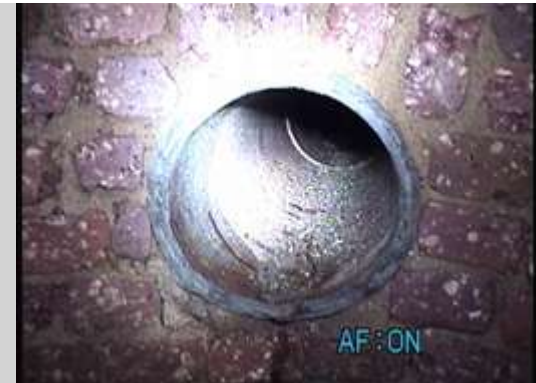
9 O'Clock Inflow

Pipe In @ 9 O'Clock

Infiltration: **None** Pipe Seal Cond: **Sound**

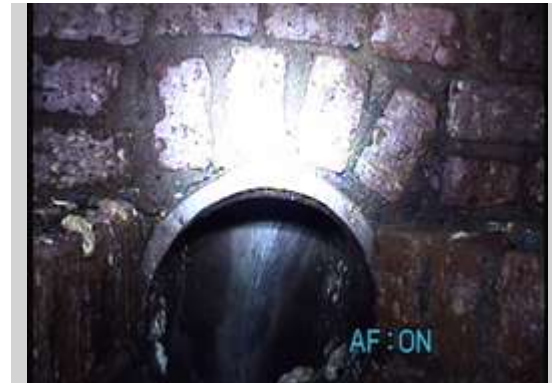
Drop In @ 9 O'Clock

Drop: Inside	Rod and Bar
Angled: Yes	Reading: 14.20 (ft.)
	Inv Depth: 15.20 (ft.)
Drop Condition: Open
